INDOOR AIR QUALITY ASSESSMENT

**Mass Rehabilitation Commission
76 Summer Street
Fitchburg MA**

Prepared by:
Massachusetts Department of Public Health
Bureau of Environmental Health
Indoor Air Quality Program
August 2016

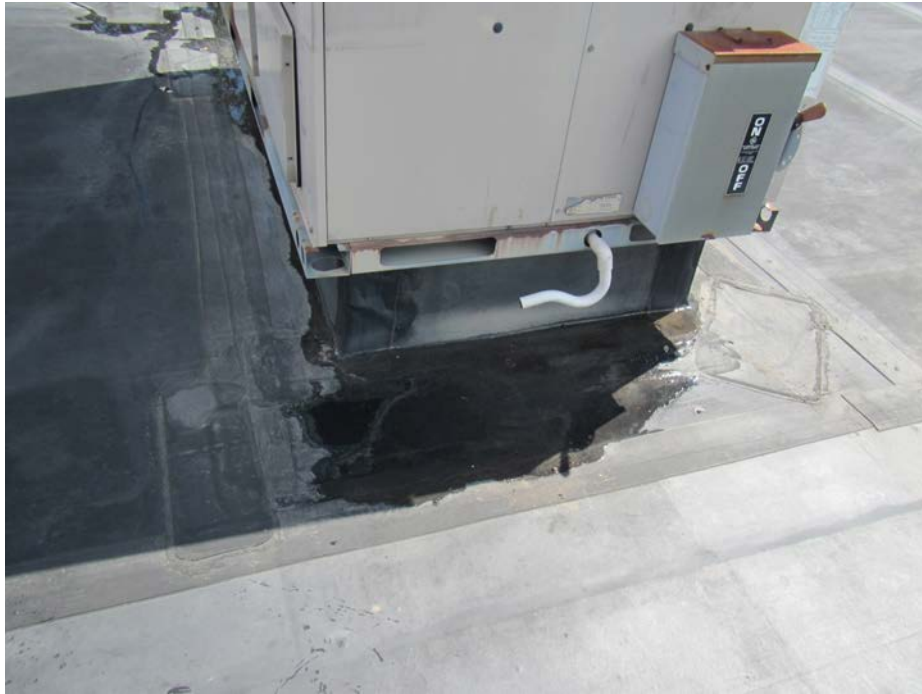
Picture 1

Fresh air is provided by air handling units (AHUs) located on the roof (Pictures 1 and 2). Air from the AHUs is filtered, heated/cooled, and delivered to rooms via ducted supply vents (Picture 3). Air is returned/exhausted through vents in the ceiling. A restroom in the waiting area had a direct-vented exhaust that turned on when the light switch was operated (Picture 4).

AHU on the roof

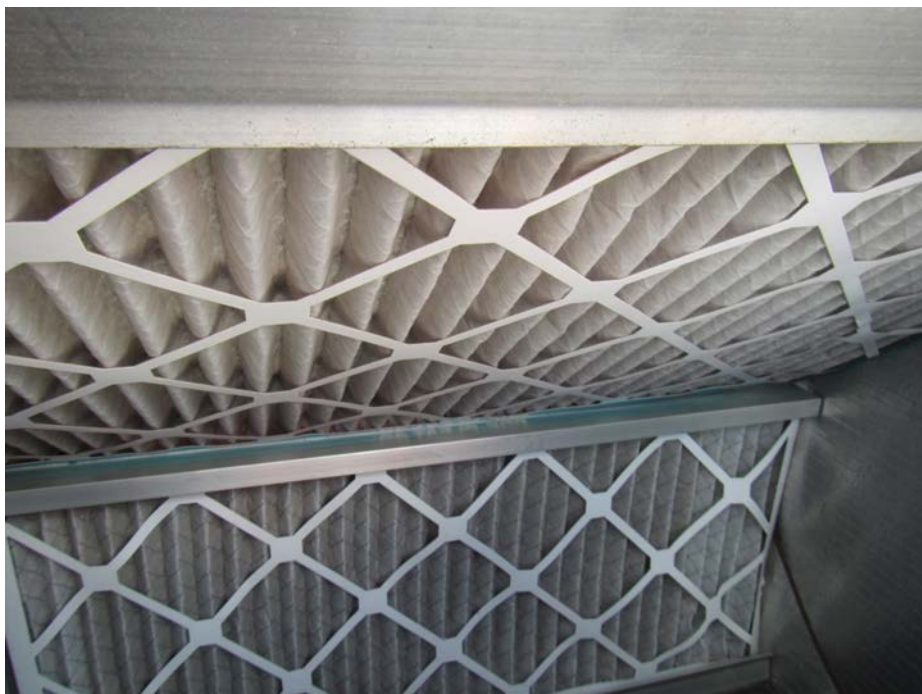
Picture 2

AHU filters

13. Reduce the use of cleaning products, sanitizers, and scented products.
14. Change filters on AHUs on a regular schedule at least twice a year.
15. Clean carpeting in accordance with IICRC recommendations (IICRC, 2012). Consider replacing carpeting that is too worn for effective cleaning with carpet squares.

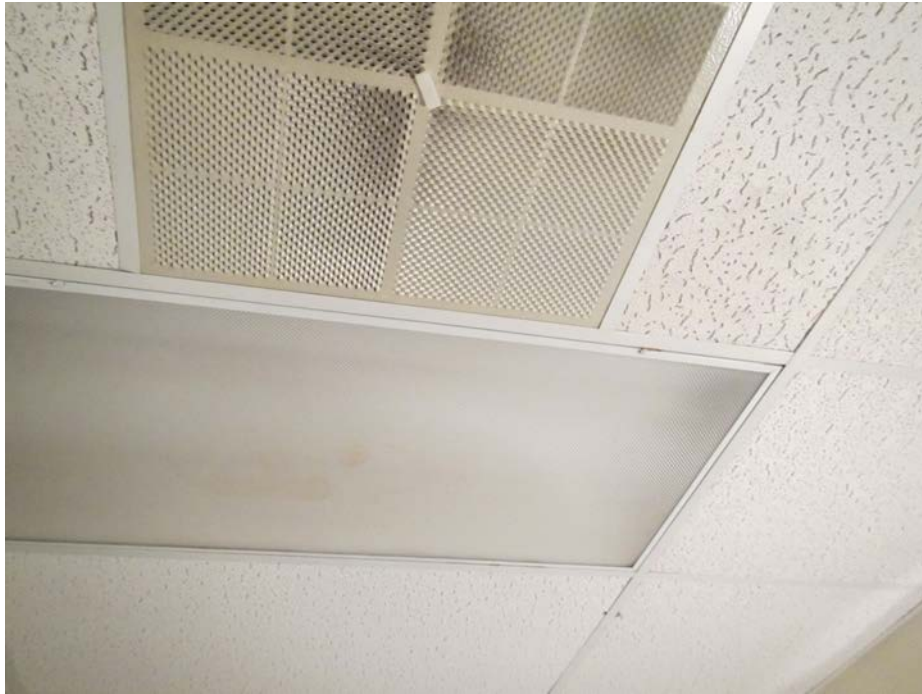
Picture 3

windows that are opened. It also suggests that increased cleaning is needed. Other areas in need of enhanced or more frequent cleaning were observed including dirt on carpeting (Picture 15), and dusty supply and exhaust vents (Picture 3) which can be sources of aerosolized particulates.

Supply vent, note dust/debris

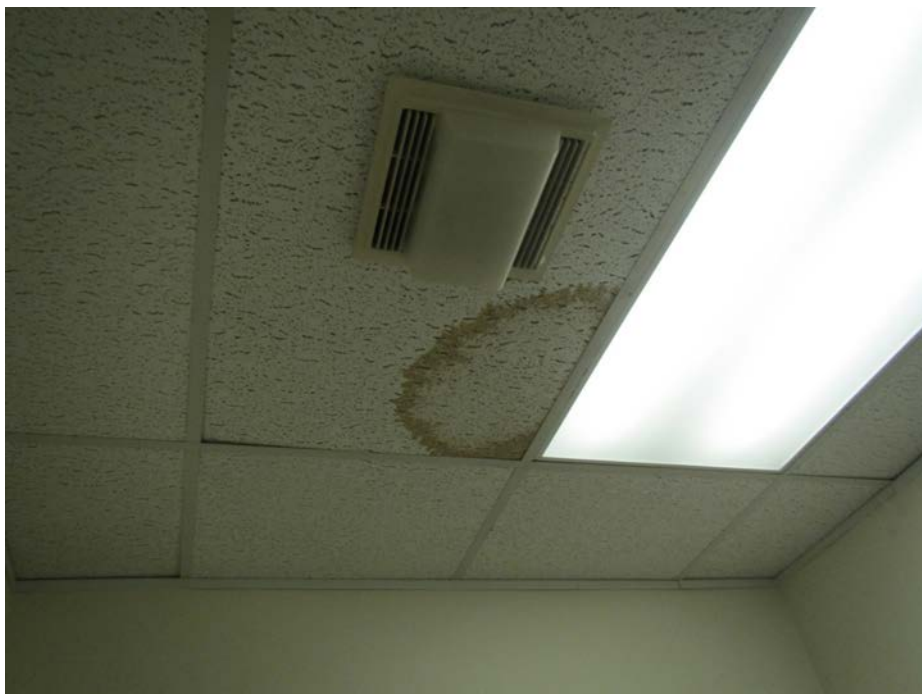
Picture 4

Exhaust vent in waiting room restroom, note water-damaged ceiling tile

3. Have the roof repaired as needed. Consider a major roof overhaul or replacement to fix areas of poor drainage and leaks.
4. Continue with replacement of water-damaged ceiling tiles. Clean water stains from non-porous surfaces as they are discovered.

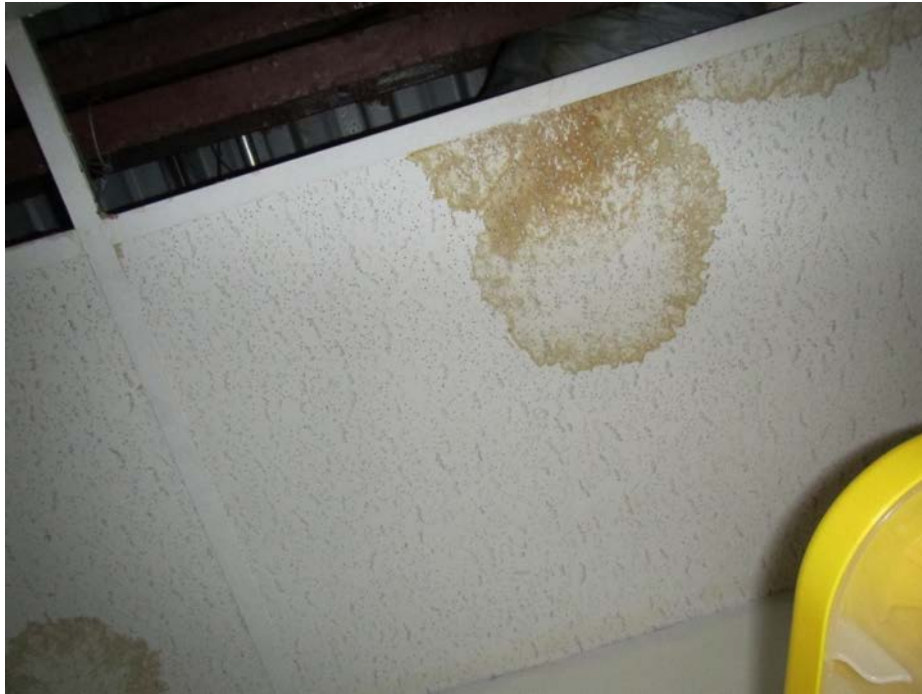
Picture 5

The main purpose of this visit was to investigate water damage reported in the building. It was reported that the landlord had replaced many water-damaged ceiling tiles in the space shortly before the visit. Additional water-damaged tiles and other signs of water damage and water infiltration were observed during the visit (Pictures 4 through 8). The area above ceiling tiles was examined in several places where water infiltration was reported. Above the suspended ceiling tile system is a space in which air ducts and other services are routed. Above that is a metal decking material. Due to the volume of open space/airflow and lack of porous materials in this space, water leaks are unlikely to lead to microbial growth above the ceiling tiles. No moldy odors were observed during this examination. Some of the metal decking was found to have rust spots indicating that water infiltration has occurred chronically in those areas.

Water-damaged ceiling tiles

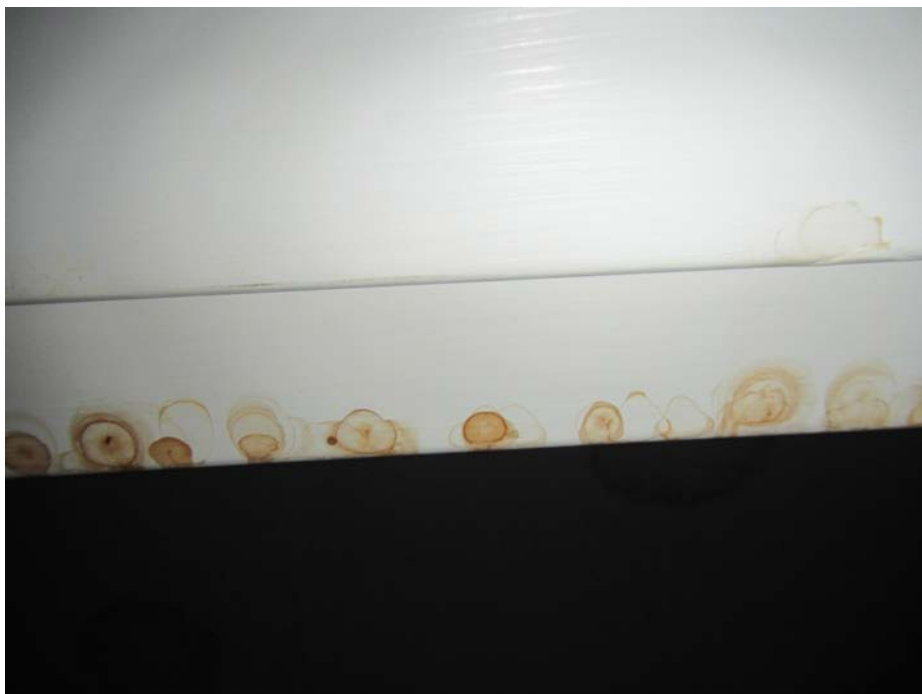
Picture 6

Water stains on closet molding

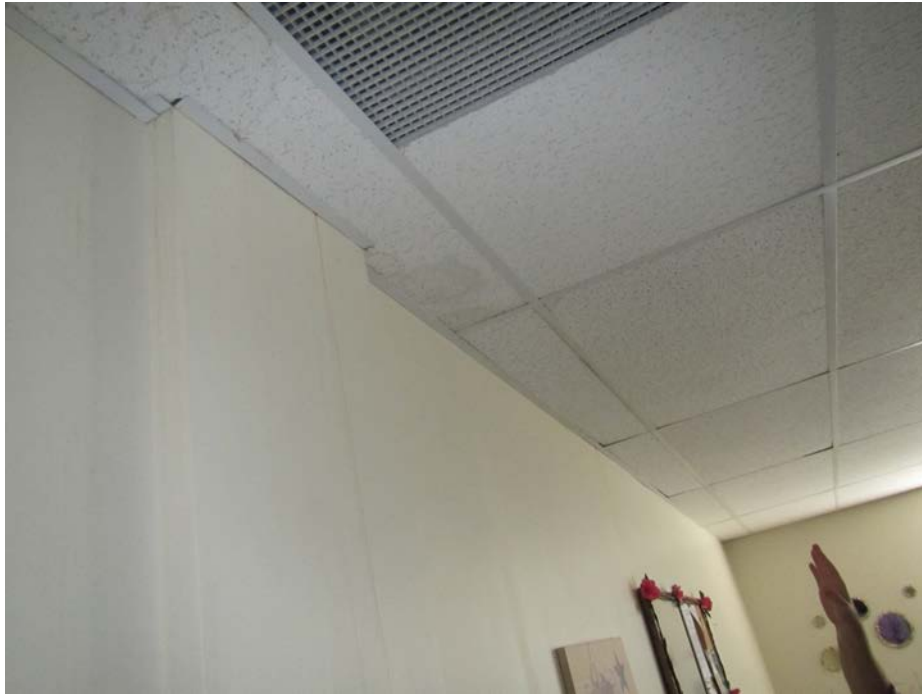
Picture 7

Water stains in wall in computer room

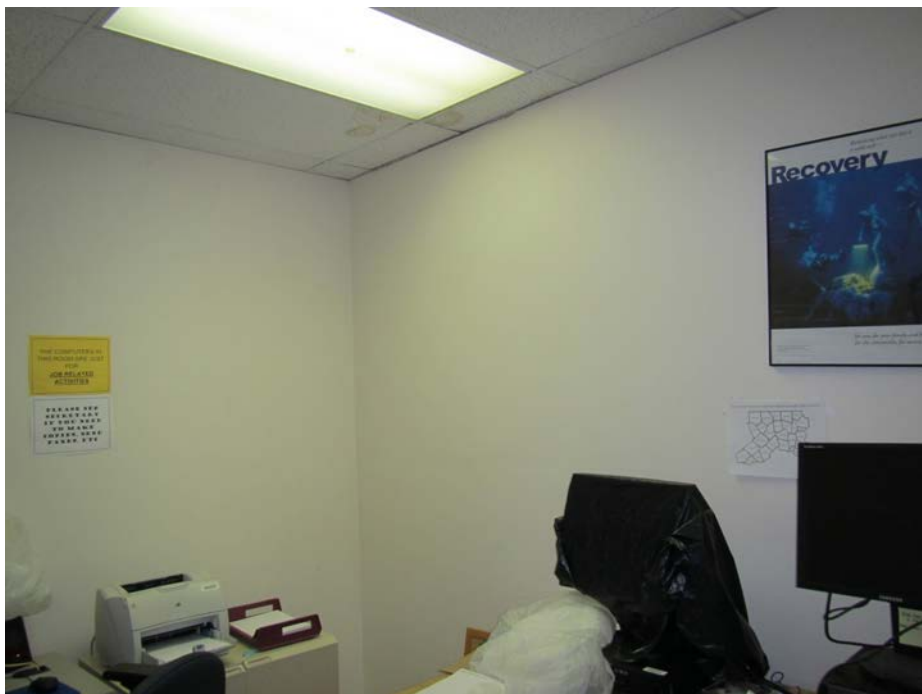
Picture 8

Plastic coverings on computers to protect from water damage

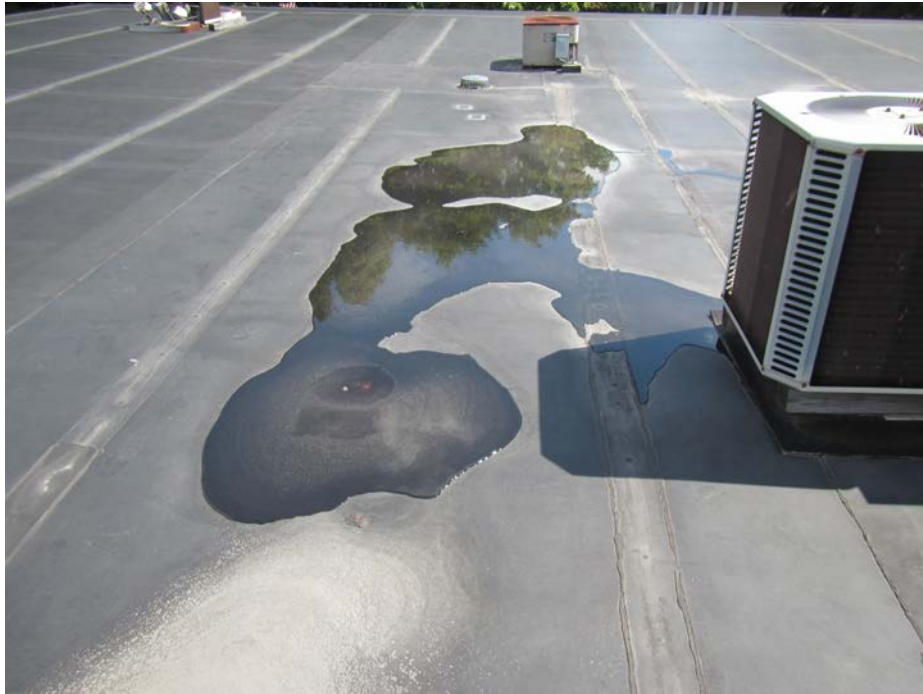
Picture 9

Water leaks originate with the roof which is of an unknown age. The roof was examined and areas of water pooling were observed (Picture 9) suggesting that the roof no longer slopes correctly to drains and/or that drains do not function well, creating conditions that may lead to leaking. Leaks have been observed to occur in the past on seams where portions of the roof meet. In addition, recent patches were seen on the roof (Picture 10), which reportedly covered areas where recent work on the rooftop cell tower may have led to roof membrane damage. The integrity of the roof membrane and proper drainage are vital to preventing water infiltration.

Water pooling on roof

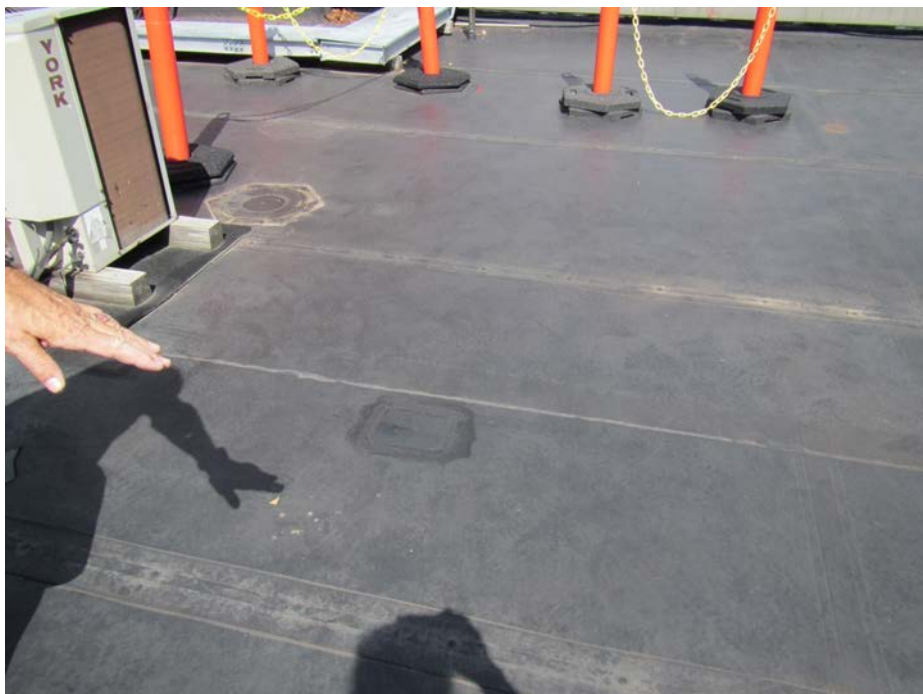
Picture 10

Roof patch

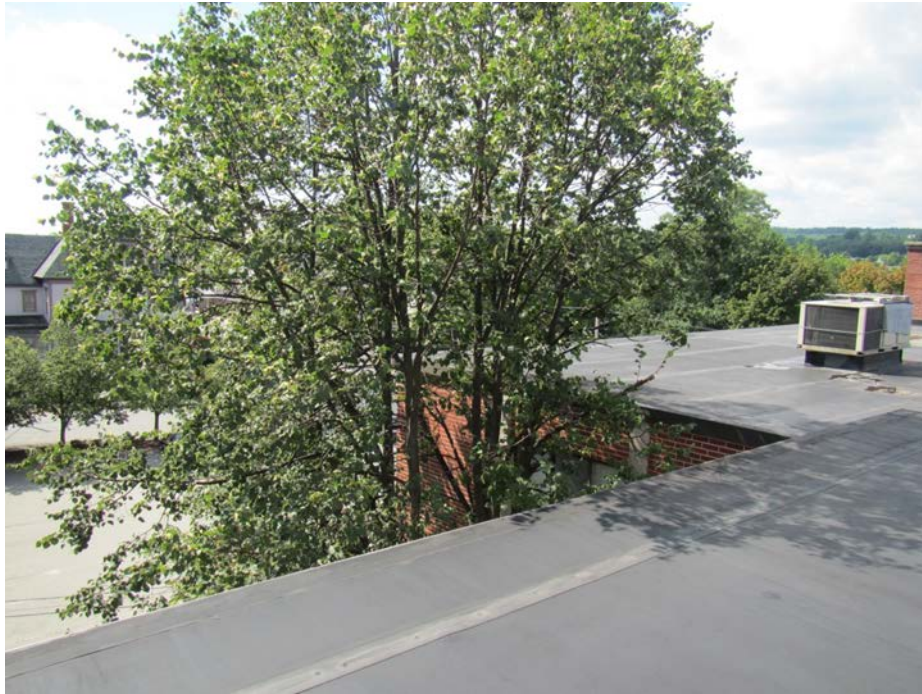
Picture 11

Trees/plants were observed in close proximity to the building and overhanging the roof (Picture 11). It was reported that several years earlier, the office had been subject to an infiltration of ants that had originated with a tree in contact with the building that was removed once the problem was discovered. Trees/plants in contact with the building can hold moisture against the bricks, can provide pathways for pests to enter the building, and can be a source of pollen and mold through open windows. They can also be a source of debris that can damage the roof membrane or clog roof drains. Trees and plants should be removed from within five feet of the base of the building and trimmed so that they do not overhang the roof.

Tree in close proximity to building and overhanging roof

7. Trim back plants from the side and overhanging the building.
8. Keep indoor plants in good condition, avoid overwatering, and avoid placing them on porous items such as carpets or paper. Also, keep plants out of the air stream of supply vents.

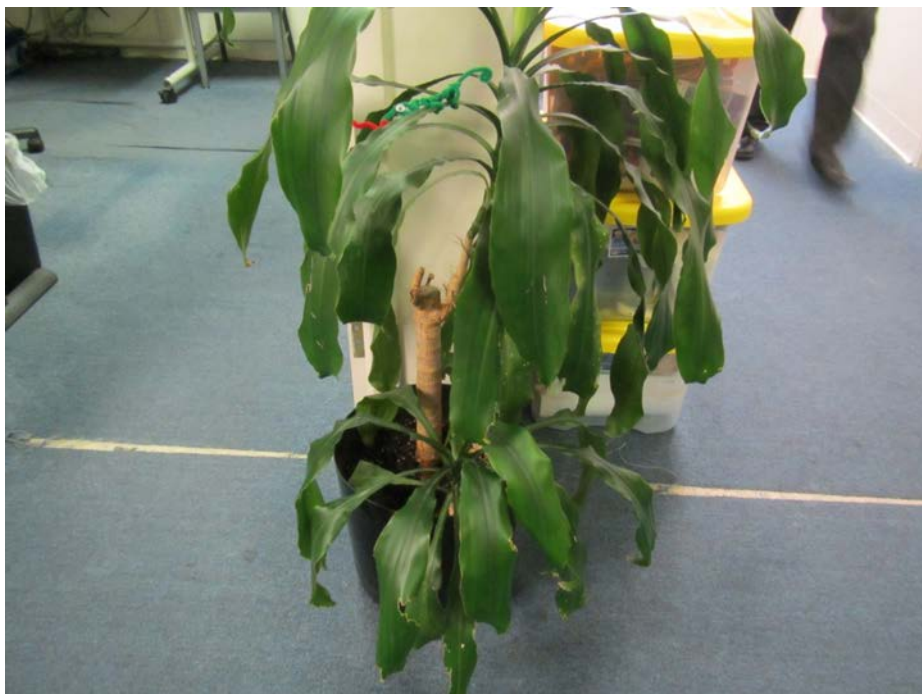
Picture 12

Plants were observed in office areas (Picture 12). Plants can be a source of pollen and mold, which can be respiratory irritants to some individuals. Plants should be properly maintained and equipped with drip pans to prevent water damage to porous materials. Plants should also be located away from air diffusers to prevent the aerosolization of dirt, pollen, and

Plant in office, note worn carpeting

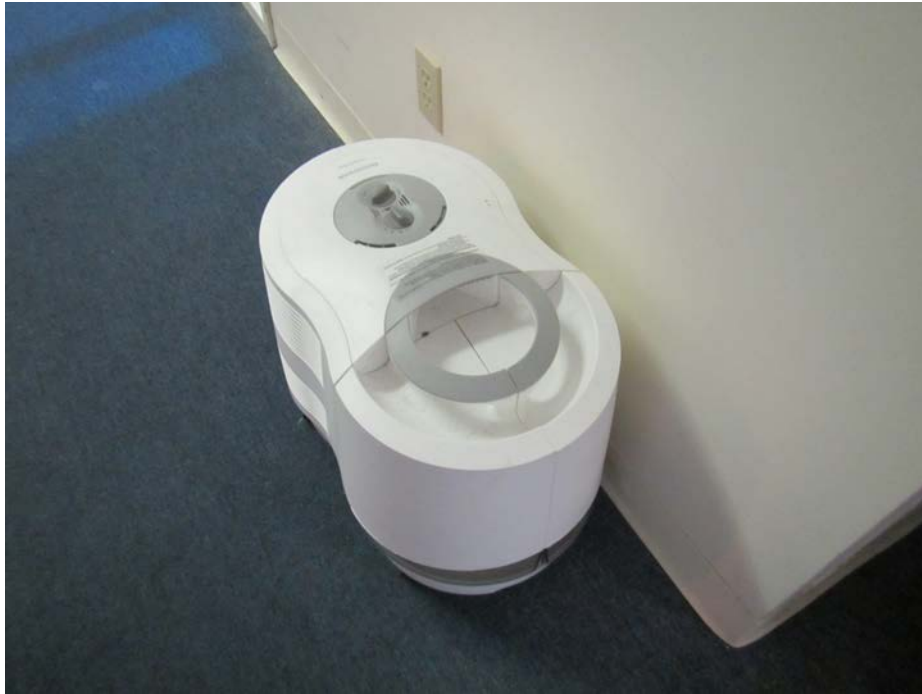
Picture 13

Humidifiers were observed in several places in the office (Picture 13), reportedly for the needs of an employee who has since retired. These units were empty and unplugged at the time of the visit. The use of humidifying equipment is not recommended in offices due to the potential of them becoming a source of microbial growth and aerosolized contaminants to the indoor environment due to improper use and maintenance. Low relative humidity indoors is a very common condition during the heating season in New England and can contribute to irritation of the skin and mucous membranes (nose and throat). To reduce the irritant effects of low humidity in the winter, the BEH/IAQ program recommends drinking water and providing enhanced cleaning to reduce irritating dusts.

Humidifier, unplugged/unused

11. Discontinue use of humidifiers in the office. For buildings in New England, periods of low relative humidity during the winter are often unavoidable. Therefore, scrupulous cleaning practices should be adopted to minimize common indoor air contaminants

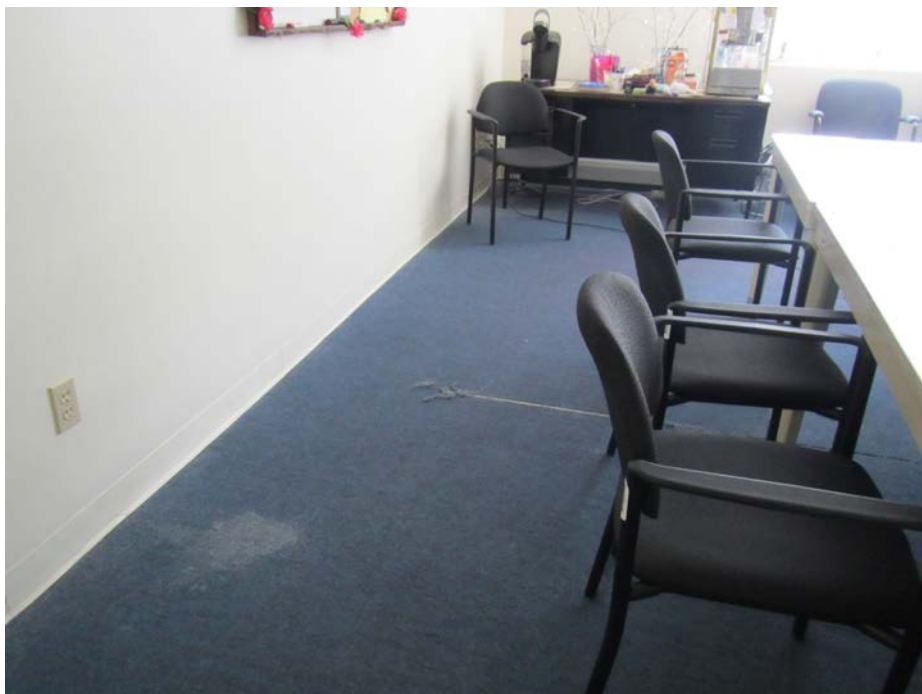
Picture 14

The offices were mostly carpeted. Carpets should be cleaned annually (or semi-annually in soiled/high traffic areas) in accordance with Institute of Inspection, Cleaning and Restoration Certification (IICRC) recommendations, (IICRC, 2012). However, carpeting was believed to be original to the MRC occupancy and therefore may be at least 20 years old. The service life of carpeting is approximately 10-11 years (IICRC, 2002). In many areas, carpeting was observed to be worn, wrinkled and stained (Pictures 12, 14 and 15). Carpeting of this age and condition becomes increasingly difficult to clean and maintain and may be a source of particulate matter to the indoor environment.

Worn and stained carpeting in a conference room

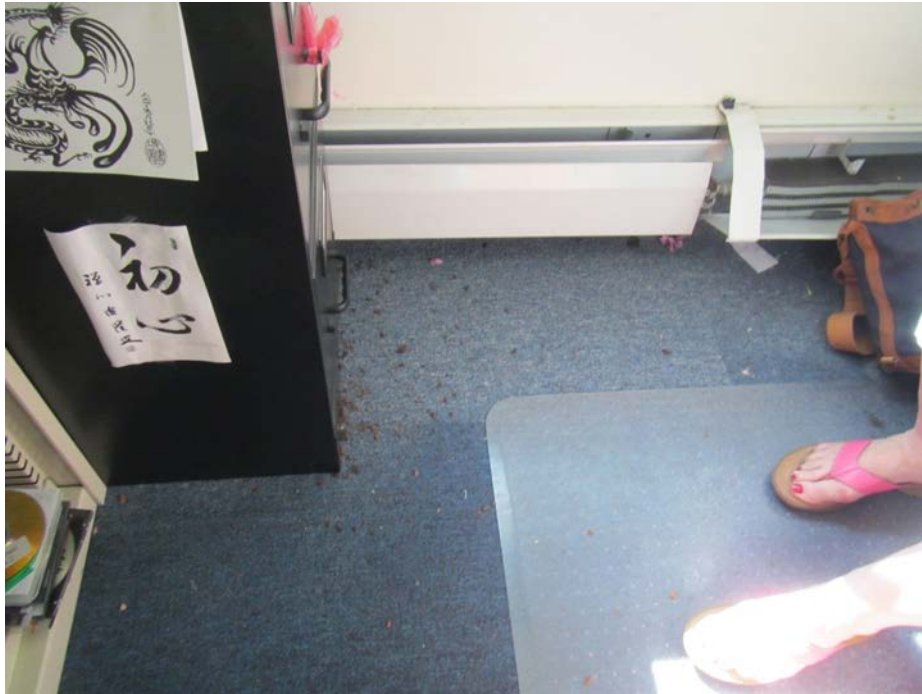
Picture 15

Worn and dirty carpeting

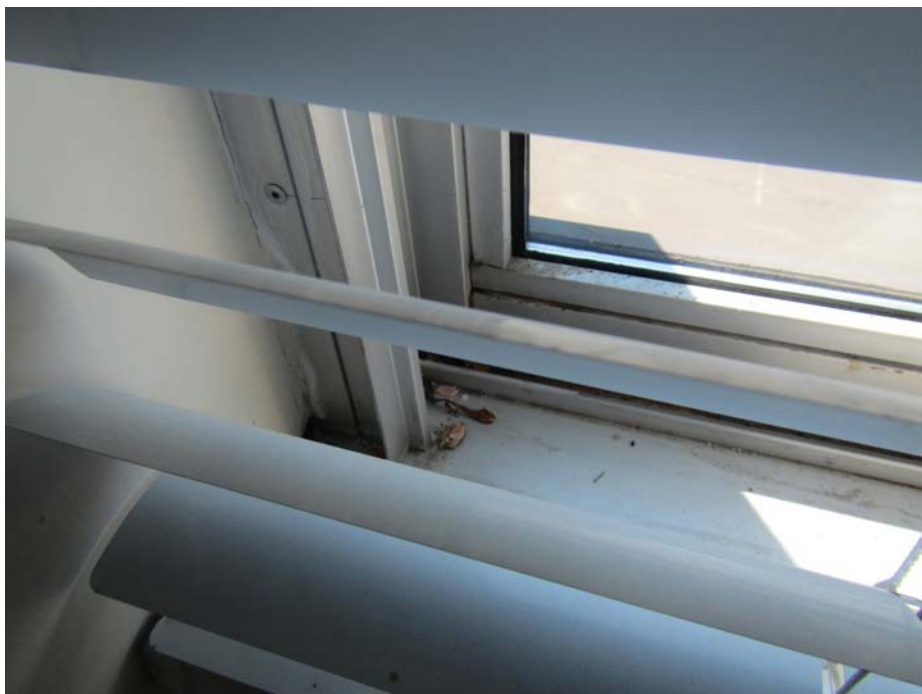
Picture 16

Dead insects were observed in windowsills in some offices (Picture 16). This suggests that there may be breaches in the building envelope, or that screens may be missing from

Insects in the windowsill

12. If windows are opened for fresh air, ensure they have intact screens and are tightly closed at the end of each day to prevent pest entry. Do not open windows during hot, humid weather to avoid creating conditions where condensation may occur indoors.

16. Clean windowsills and other hard-to-reach areas regularly.
17. Reduce accumulated materials on flat surfaces and store in an organized manner to allow for thorough cleaning.
